DERELICT BUILDING GRANT PROGRAM

Derelict Building Address: 301 State Street, Guthrie Center, IA 50115

Derelict Building Grant Program
Supporting Materials – Photo Descriptions
City of Guthrie Center

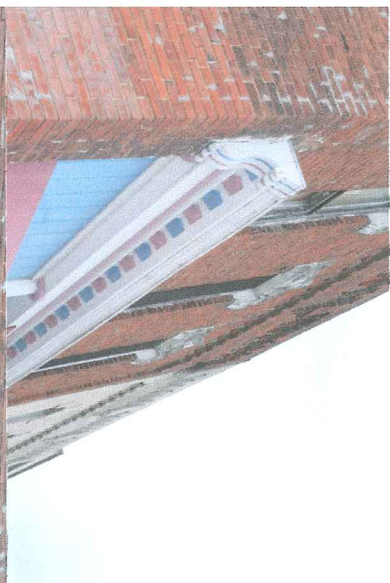
8

7. West Wall view – back 1/3 view. Appears there is evidence of past repairs to mortar.
8. West Wall view at sidewalk level showing basement windows and potential foundation problems.

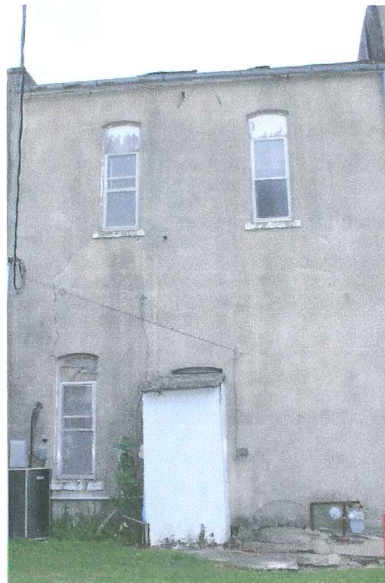
18

18. Rear view. There are actually large cracks in the concrete covering that do not show in the photo without zooming in on the cracks. You can see the roofing material is not secured to the roof.
